REMOTE SEARCH FOR GAMMA SOURCES AT THE DRY STORAGE UNIT 3A IN ANDREEVA BAY AND THE DETERMINATION OF THEIR DOSE RATES DURING ACTIVITIES FOR IMPROVEMENT TO THE RADIOLOGICAL ENVIRONMENT

Technical paper
DOI: 10.2298/NTRP1203311I

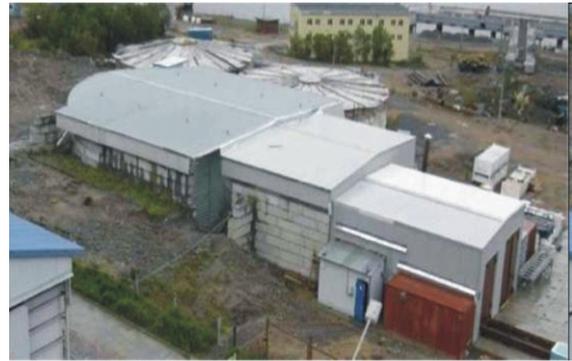
Figure 1. DSU 3A tank site at the NWC “SevRAO” – branch of the FSU “RosRAO”, Andreeva bay, Murmansk region (27. 12. 2011)

A remotely controlled BROKK robotic manipulator, HIAB manipulator crane and video control systems were employed in the IRE work at the DSU 3A. Radiation monitoring at the DSU 3A was carried out using the Automatic System for Radiological Environment Monitoring (ASCRO) system, a CARTOGAM gamma camera, portable γ -radiation detectors, and an air sampling system (radiation monitor). The CARTOGAM gamma camera was used in all stages of the work involving high-energy radiation levels for remote location of the most dangerous gamma radiation sources and the evaluation of their dose rates. The use of the ASCRO system and CARTOGAM gamma camera made it possible for us to avoid unauthorized exposure of the staff involved in the operations at the DSU 3A site. We had previous experience in this field at the temporary solid radioactive waste (SRW) storage site (open pad) in Gremikha, NWC “SevRAO” – Branch of FSUE “RosRAO” [1, 2]. Also, the isotopic composition of the sources detected by the CARTOGAM was established using the ISOCS γ -spectrometer [3]. The objective of this work was to implement the remotely controlled replacement of the old concrete covering at the DSU 3A in Andreeva Bay, Murmansk Region. The DSU 3A tank containing concreted spent fuel assemblies (SFA) was covered by iron biological shielding segments and lead sheets (fig. 1).

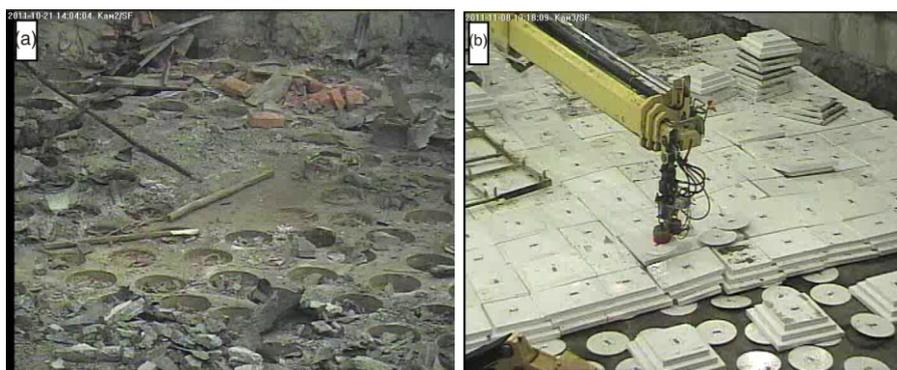
Figure 5. DSU 3A surface
 (a) – concrete slabs and blocks removed (20. 11 2011),
 (b) – HIAB lays the caps and biological shielding segments (20. 12. 2011)

After concrete slabs had been removed from Sectors 1 and 2 of the DSU 3A surface, the concrete base with the SFA cells was exposed, figs. 4, 5(a), and

the radiation level increased significantly. Then the DSU 3A surface was vacuum cleaned. After that, the HIAB covered the SFA cells with marked metal caps. Above the caps, 15 cm thick puzzle-shaped biological shielding segments weighing 380 kg were laid, fig. 5(b). As a result, the radiation level was reduced.

It would have been easier, technologically speaking, to remove all the concrete slabs and blocks from the entire DSU 3A tank surface and to install the biological shielding segments afterwards. But, in this case, the radiation level would have increased to dangerous values, even for the operators in the control module. Therefore, this was done in two stages: first, the concrete covering of Sectors 1 and 2 was dismantled and the sectors covered with metal shielding segments; afterwards, the same was done for Sectors 3 and 4 (fig. 5).
